System Rejuvenation on Tight Site on Whaley Lake, Dutchess County, New York

Problem: Failing metal septic tank in need of a rejuvenated leach field on a beautiful recreation lake in Dutchess County NY.

Solution: Use a lightweight and small footprint Fuji Clean Model CE5 (Design capacity; 500-gpd) to discharge highly treated & oxygenated effluent into existing leach pit for rejuvenation.

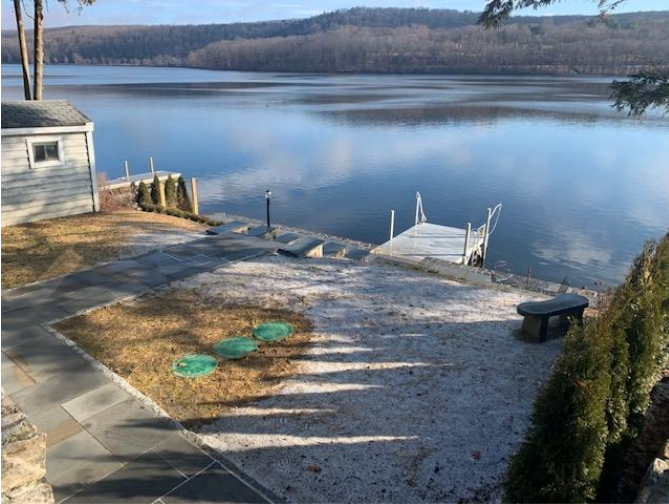
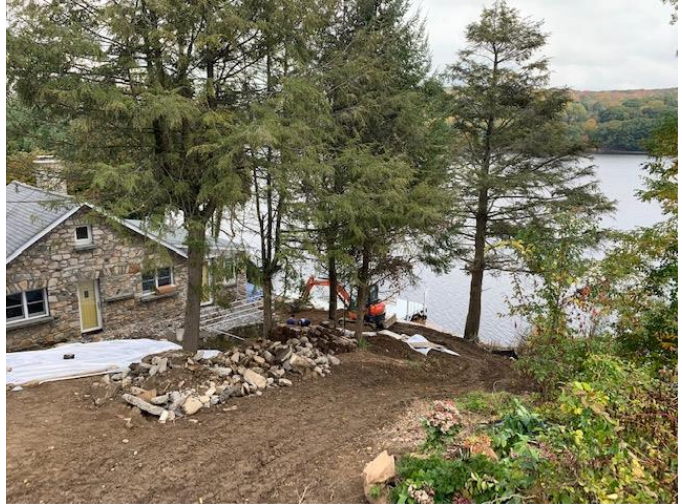
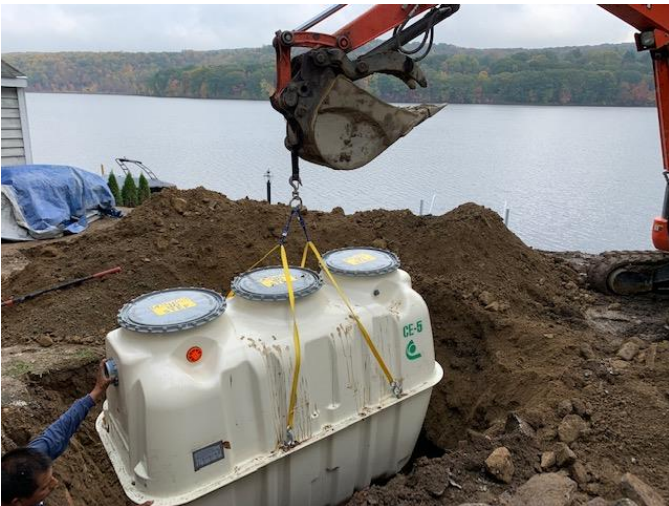
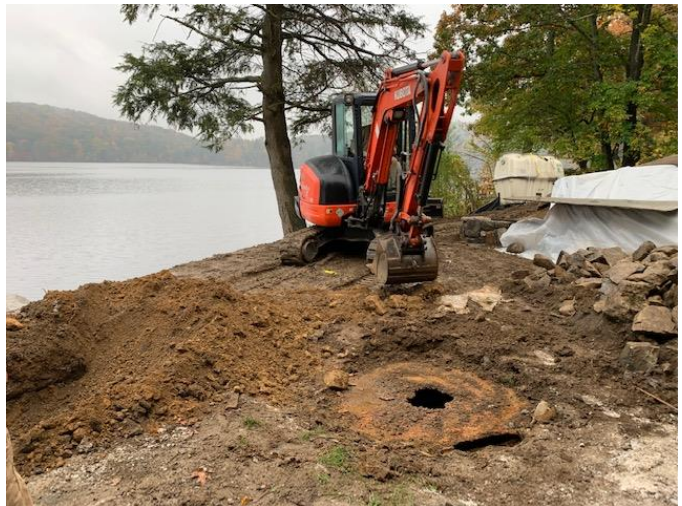
- Sloping site with a small footprint
- System within 30' of lake edge
- Replacing failed old metal tank
- Dispersal into existing leaching pits

- Fuji Clean Model CE5 (Design capacity; 500-gpd)
- Proven treatment results of BOD <15 mg/L and TSS <15 mg/L
- One tank treatment with tiny footprint and low profile (85"L x 44"W x 62"H)
- Lightweight (>400 lbs.) easy to maneuver into location
